# So You Want To Restore a Falcon!

By Dick Harrington

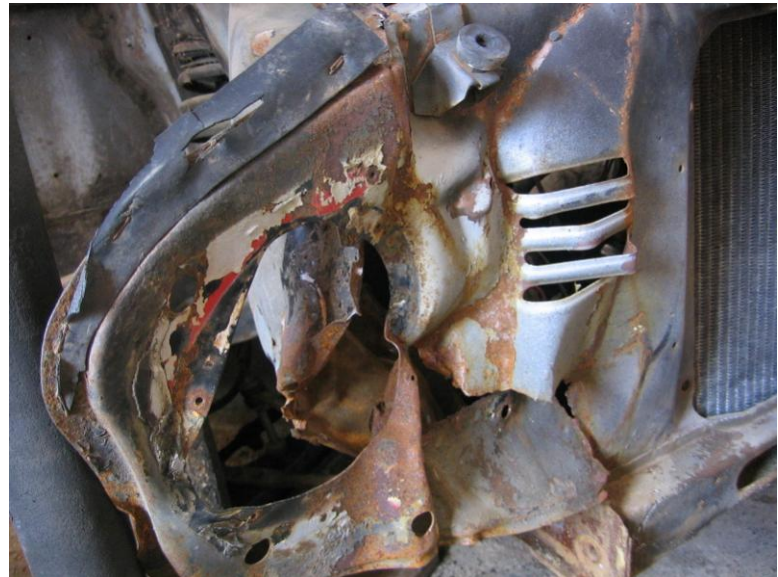
The good news was the frame was fine. The upper control arm upper shaft was bent, so it would need replacing, to bad since it was fairly new. The shock tower was also straight. So, the first step was to remove the front inner fender. The spot welds were drilled out carefully since more than likely some of the inner fender

Radiator support pretty well crunched.

dolly was used to bring the radiator support back into its original shape. There was some rust where battery corrosion had taken place and that actually helped in reshaping the area in front of the battery. The inner fender was also hammered out using a welding bench as a flat surface to hammer against. It began to look like both the radiator support and the inner fender could be saved.

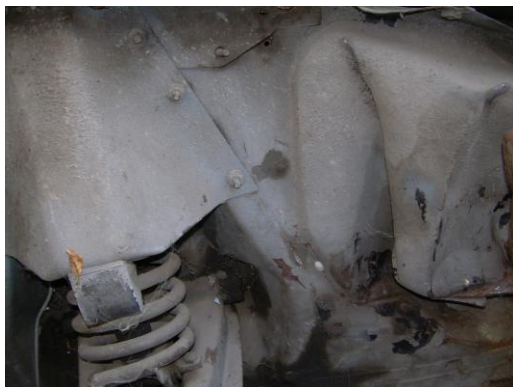
Inner fender damage

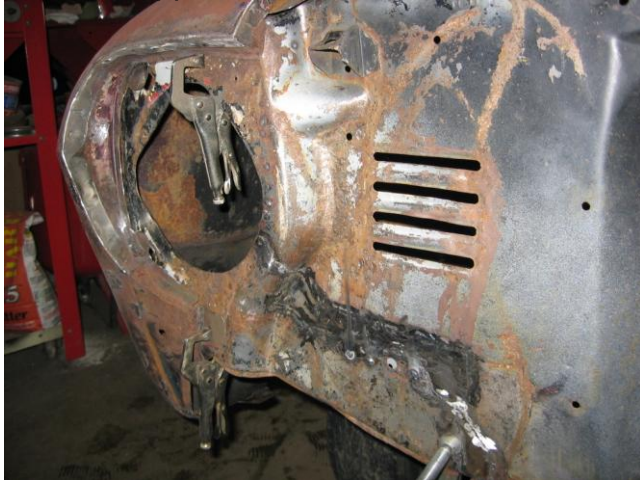
Radiator support un-crunched! Missing paint indicates where the creases were. If you look close, you can see where some metal patches were stitched in to replace the rusted portions.

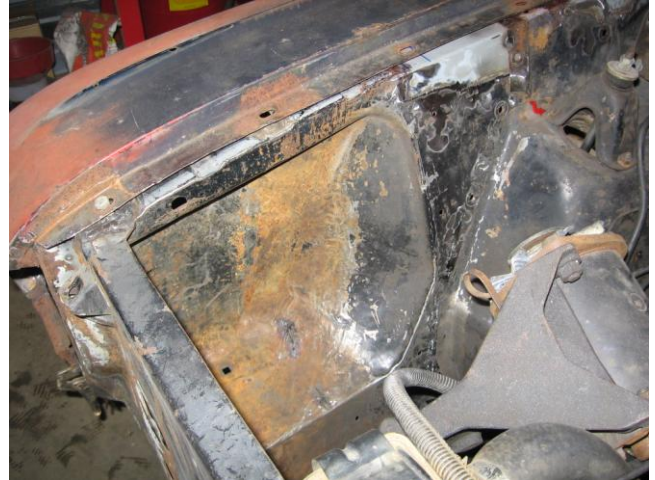
The inner fender straightened and welded back into its proper place.

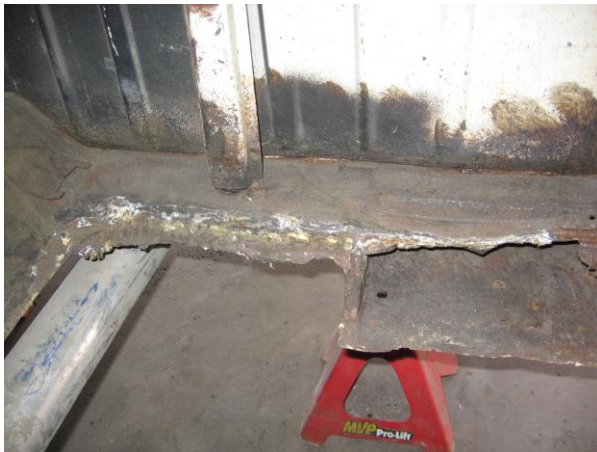
Examination of the Ranchero (once it arrived in Delhi) showed the floors already replaced as well as patched lower quarters. In both cases the quality of the work was poor. The floors had significant patching over the top of rusted metal. The quarters had as much as 3/4" of bondo in some places. In other areas, bondo was placed over the top of rusted through sheet metal. Before you begin rust repairs, the first thing you need to understand is paint is expensive (the Sprint Hardtop has \$1500 worth of paint, no labor). The second thing is paint is only as good as what it is stuck to. Paint does not hide defects, paint does not stop rust (if it already exists) and a good paint job takes way more preparation than actually spraying the paint.

The floor patch behind the driver has been removed; if you look close you can see sealant and brazing.

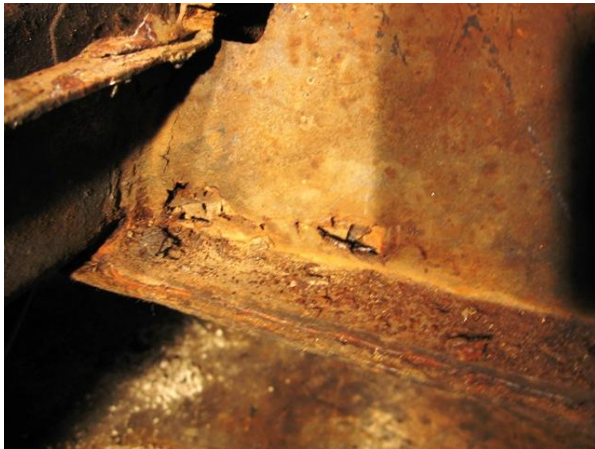
While the floor pans were out, some repairs were made to the torque boxes. (Torque boxes are additional bracing added to V-8 powered Falcons to stiffen the uni-body for the additional horsepower of the V-8). It is much easier to repair the torque boxes from above than below. The torque box on the right side of the Ranchero had about five pounds of sand in it. There is a body plug on the torque box just behind the front tire. It was missing leaving an opening for the sand to enter through.

Rust damage at right front torque box

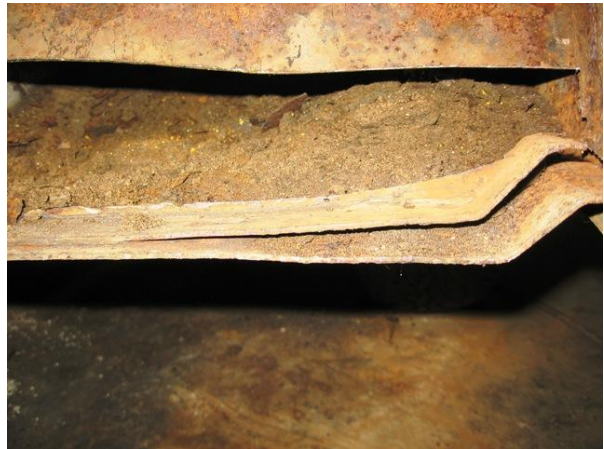
A rusted section of torque box is cut out. Notice the sand that collected inside.

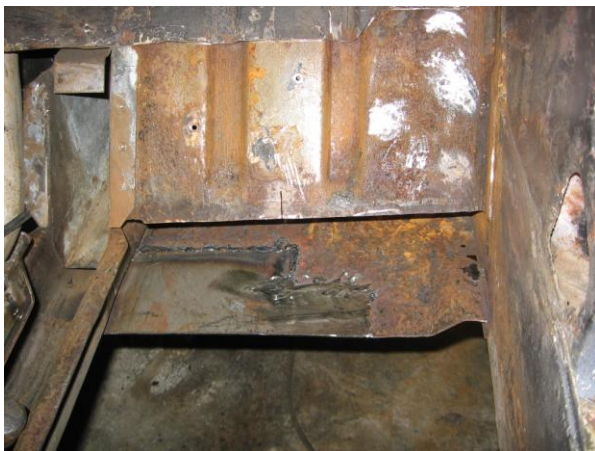
The right floor of the torque box repaired

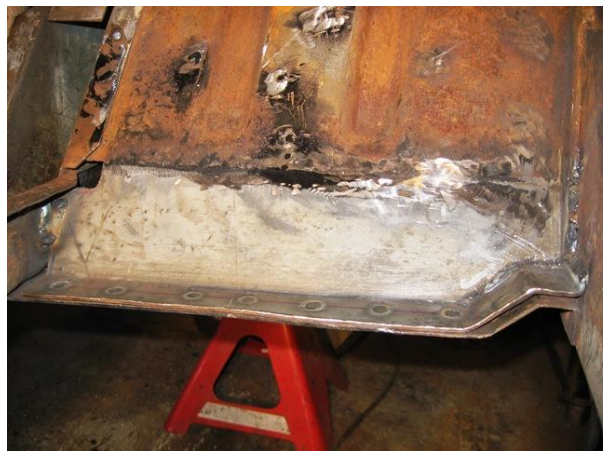
The back side of the torque box is repaired; the toe board patch is next.

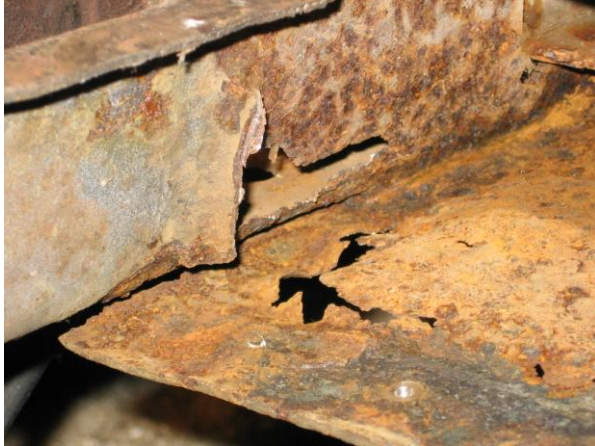
A small rust through had taken place inside the torque box on the frame rail, it was patched with a piece of the structural steel stud. Again, before welding the floor pan, a heavy coating of paraffin based rust proofing was brushed on the inner surfaces of the Frame rails. All the rest of the Ranchero uni-body frames were in great condition.

The only frame damage was inside the torque box

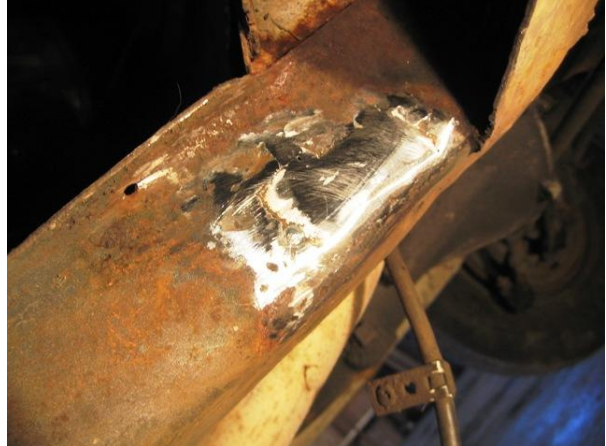
The frame rail is repaired prior to patching the torque box.

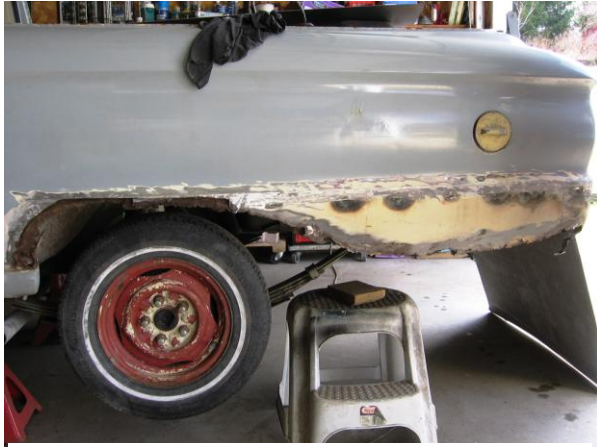
Rear view of left rear quarter after the Bondo and overlapped metal patch was removed. The original paint was underneath the patch.

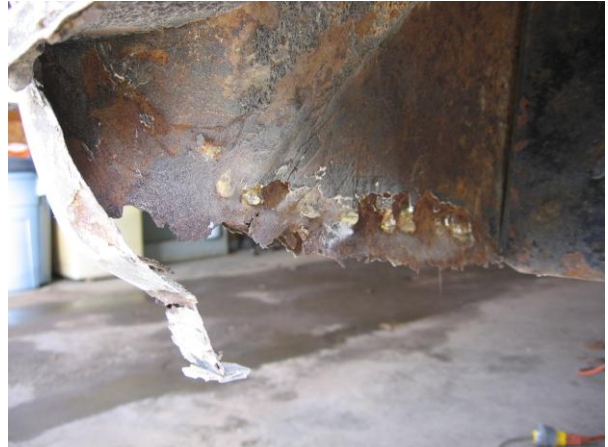
This is a view looking at the back side of the left rear quarter. If you look close, you can see the brazing puddles left

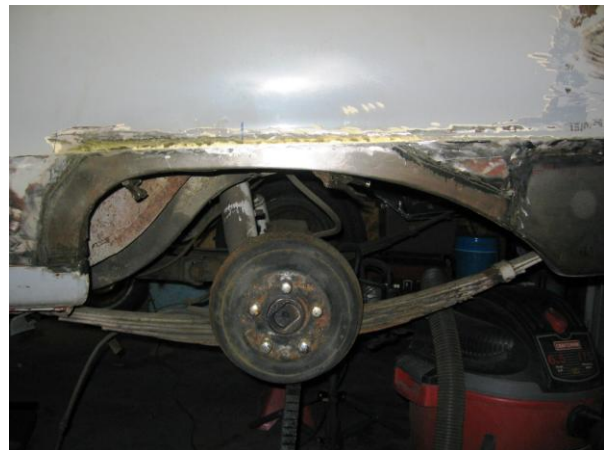
The wheel lip on the driver's side was also showing serious decay, so the damaged area was cut out. Again the inner panel was repaired first. Shaping the patch required making a wooden buck to use as a form. The pattern that was made at the Syracuse Ford show was used to make a heavy cardboard pattern of the wheel well shape. It was then transferred to a 2x10 to make a wooden buck. A piece of sheet metal was cut to the rough shape of the buck, clamped to the buck and gradually hammered to fit the buck.

The wheel lip patch has been MIG welded into place.

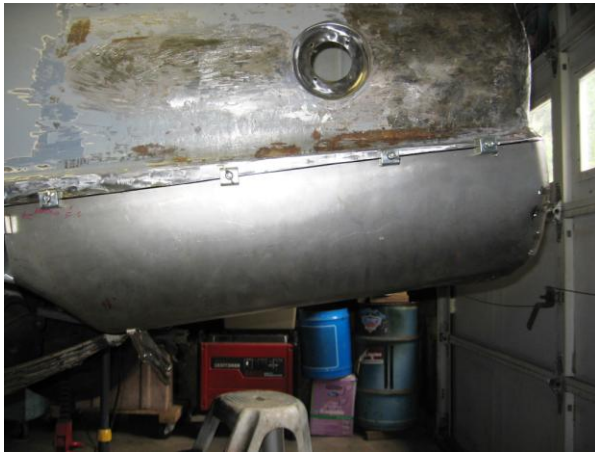
The lower quarter panel patch is clamped in place using vice-grips and seam spacers. A series of 3/8" long welds are placed about 4" apart. This is to reduce heat build-up that may warp a panel.

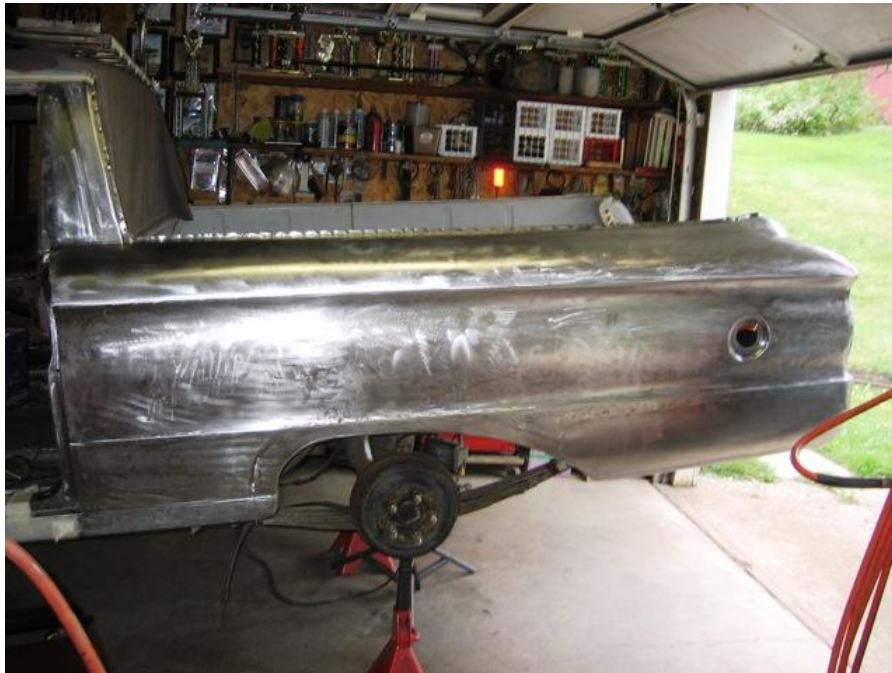
The left rear quarter sheet metal is repaired, the paint has been stripped (stripping paint will be discussed in a future installment), and is ready for primer. After each area is repaired, the area was stripped and painted with an epoxy primer to prevent any further rusting.

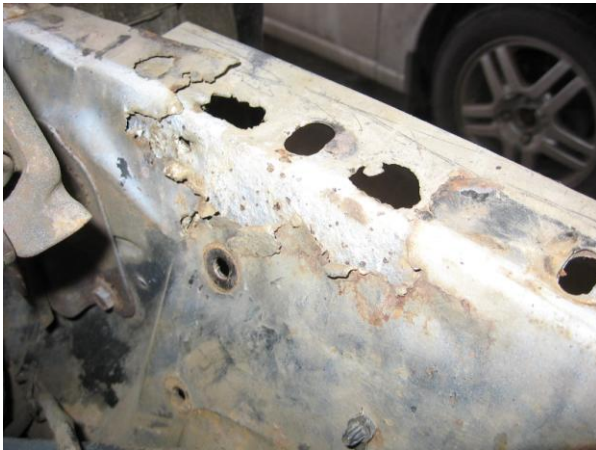
All three of my Falcons share one thing in common; rust at the center-top of each inner fender. The most likely cause for rust in this area is a reinforcement piece behind the inner fenders. It sits in the wheel well and moisture that the tire kicks up gets trapped between the inner fender and this reinforcement. Of course no paint gets on the inner surfaces and it doesn't take many years for the damage to be done.

Typical inner fender rust. Notice the inner fender and the reinforcement plate underneath. Both will get patched.

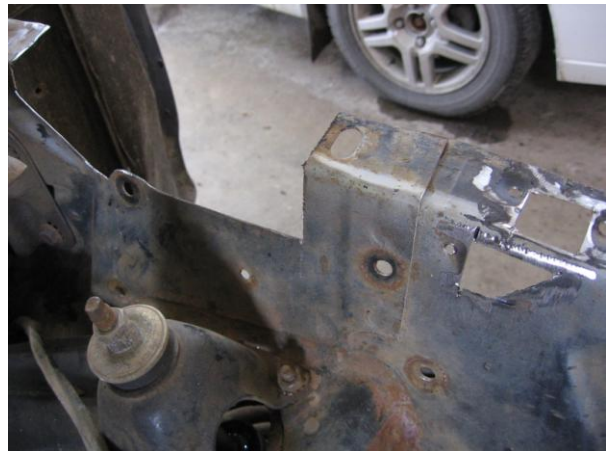
The reinforcement plate is removed and the rusted inner fender material is cut out with a 4" cut off wheel in a pneumatic grinder.

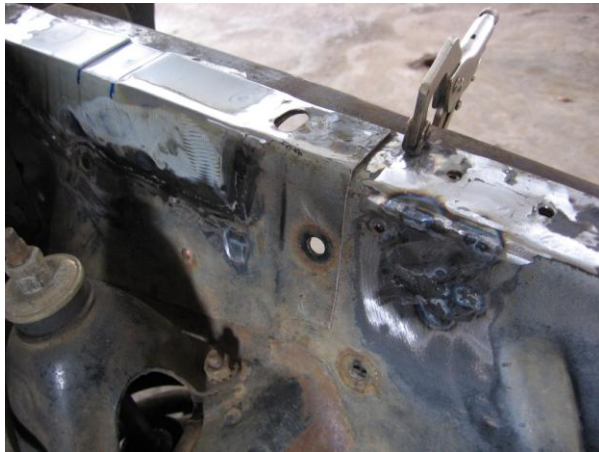
The patching is completed and the reinforcement plate is clamped on for a trial fit.

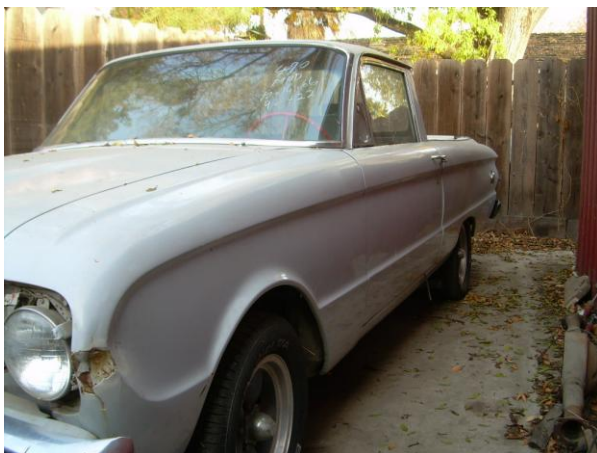
Notice the dent in the front edge of the fender.

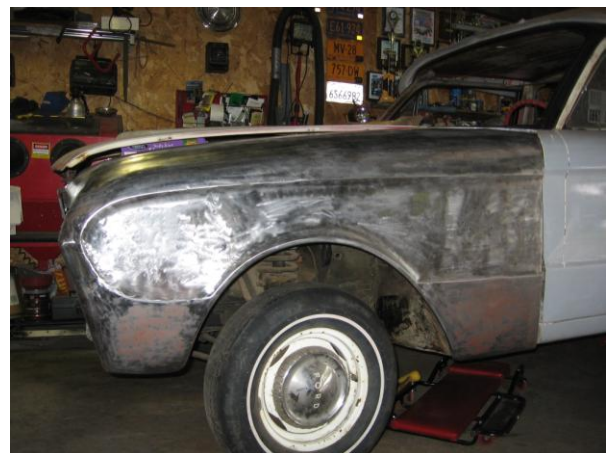
Dent is repaired; fender is stripped and is ready for primer.

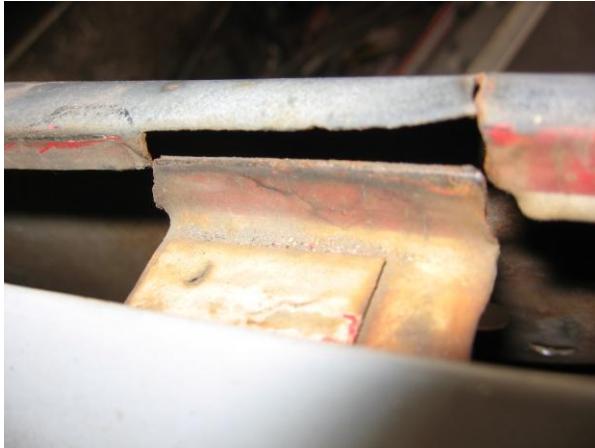
channel. There is only one middle attachment point and that is between the front vent window and the side door glass. This joint fatigues from the closing of the door and the harmonics it causes. The Ranchero was worse than any other Falcon door I have seen. It must have been slammed shut often, more than likely by someone using the vent window post as a handle.

The dreaded fatigue crack! This is on the driver's door.

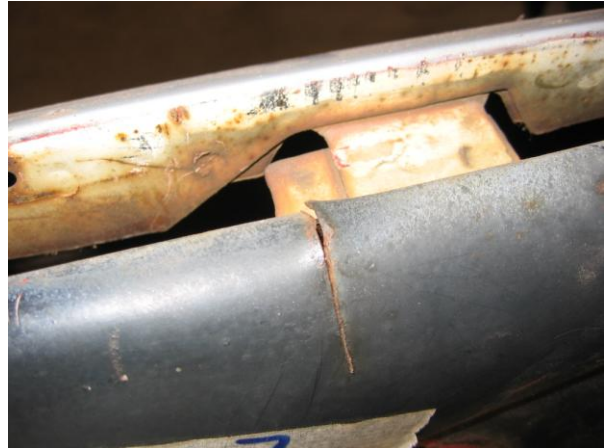
This is the view from the inside of the door. It took a lot of door slamming to create this much damage.

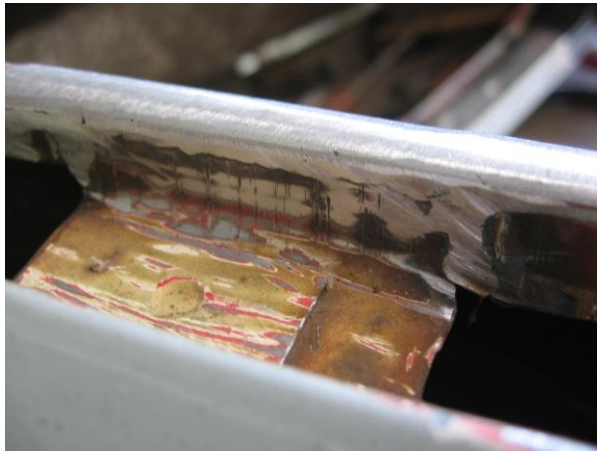
The fatigue crack is welded back together.

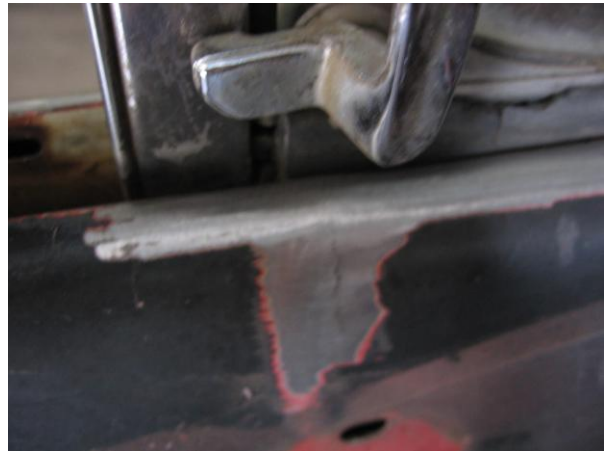
The inner door panel crack is welded shut. The vent window was re-inserted to check the fit around the repair.

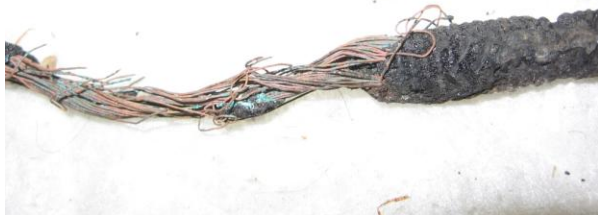
The taillight harness that got melted, this was over the left rear wheel well.
