# So You Want To Restore a Falcon!

By Dick Harrington

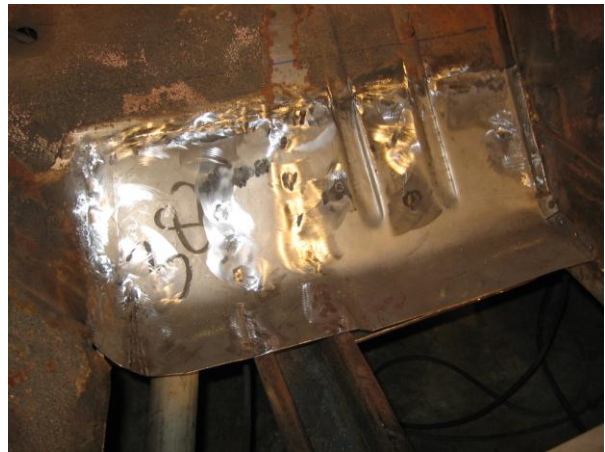
New right toe board is welded in place

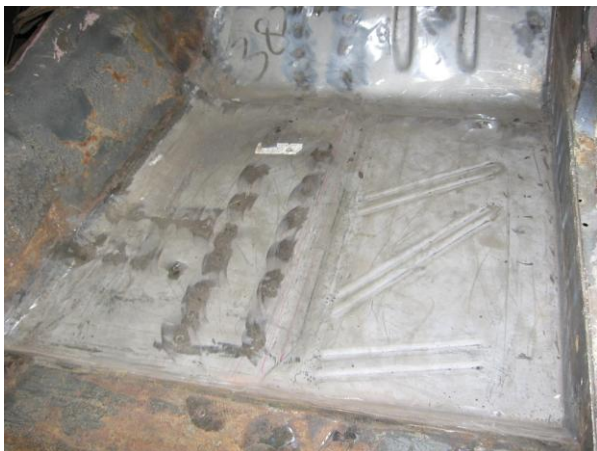
New right floor pan is in place.

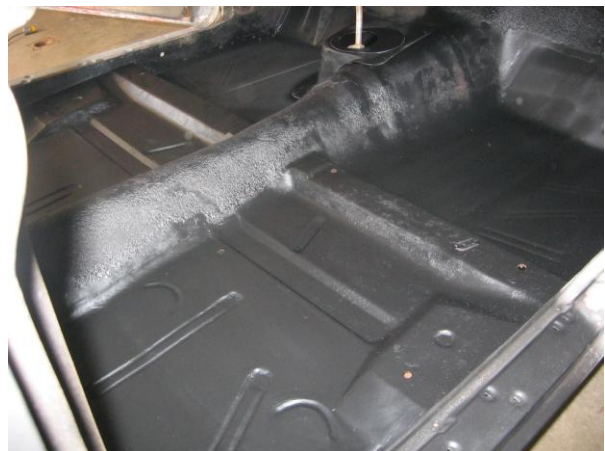
All the floor pans finished and coated with epoxy primer.

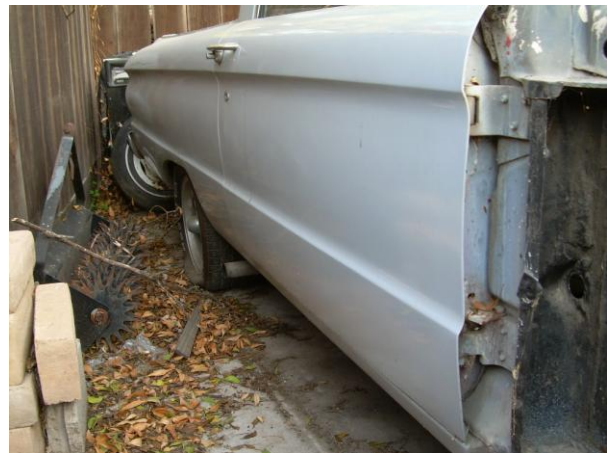
At first look, the rear quarters looked to be in pretty good shape, the photo's sent indicated few problems and when it was sitting on the delivery truck it also looked pretty good. Looking through the inspection panel holes on the inside of the bed did indicate some previous repairs had been made. A little exploration with a pick hammer left no doubt, serious repair was required at the quarters. In some spots the Bondo was  $\frac{3}{4}$ " thick covering sheet metal patches that were brazed in place. There was no choice but to chip off the Bondo, grind through the brazing and remove the metal patches.

Right side looks ok in this photo. It is not a close up, but it leaves plenty of room for optimism.

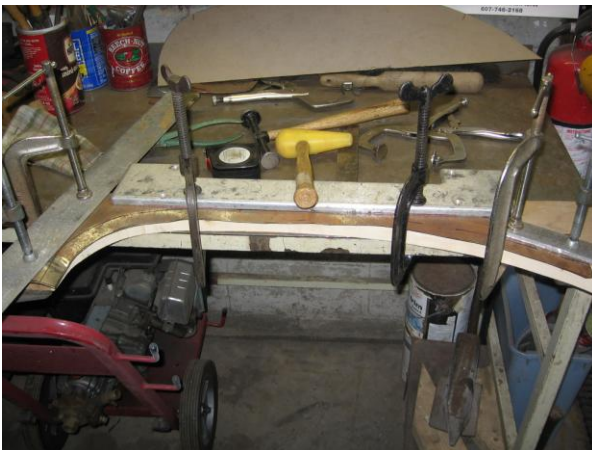
The wheel lip on the driver's side was also showing serious decay, so the damaged area was cut out. Again the inner panel was repaired first. Shaping the patch required making a wooden buck to use as a form. The pattern that was made at the Syracuse Ford show was used to make a heavy cardboard pattern of the wheel well shape. It was then transferred to a 2x10 to make a wooden buck. A piece of sheet metal was cut to the rough shape of the buck, clamped to the buck and gradually hammered to fit the buck.

The wooden buck and a piece of sheet metal are clamped to the work bench. The yellow plastic mallet is the tool for hammering with. The cardboard wheel well template can be seen in the background.

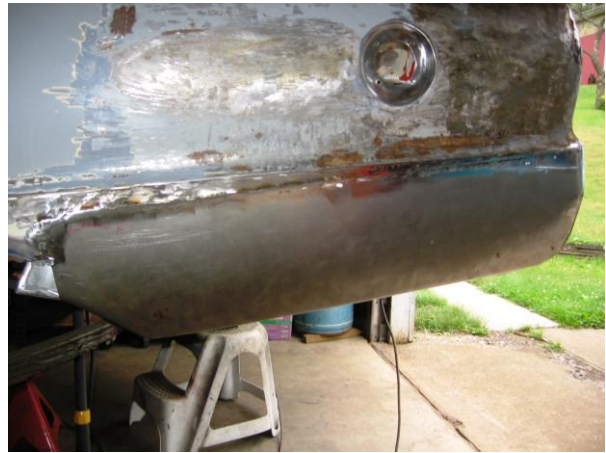
Lower quarter panel patch is welded into place.

As each patch panel was completed, it was temporarily clamped or screwed to the vehicle and a 4"x 1/16 inch cut off wheel was used to cut both the patch and the original sheet metal simultaneously, creating a butted seam. It was then stitch welded in place with a MIG welder. Every inch of the weld is then checked with a light held behind the seam to be sure that no light passes through. A missed hole in the weld is a place that moisture will get through. There is no greater fear than having a perfect paint job ruined by a blister due to a flaw in the welding.

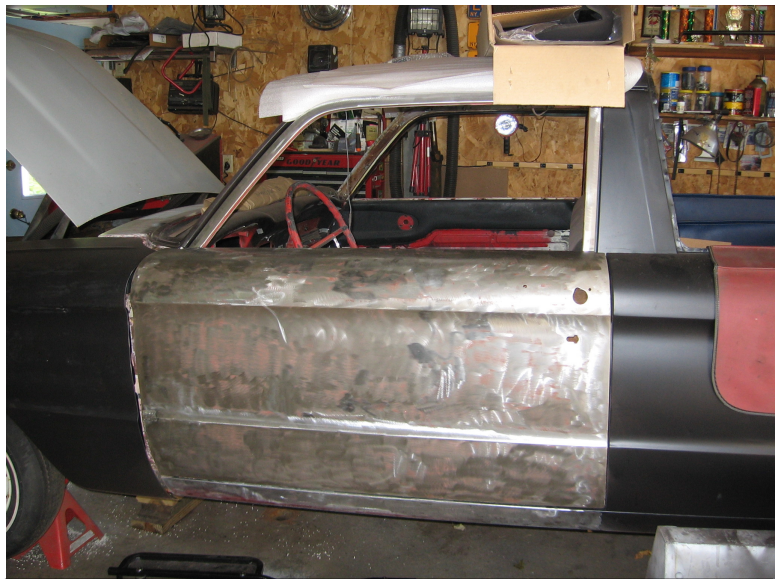
The driver's door chemically stripped, but not sanded. Notice that the rear quarter and the front fender are already stripped and primed.

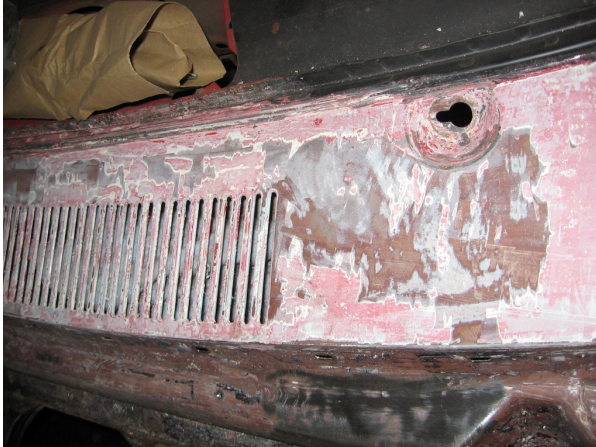
This is a view of the cowl after the first coat of stripper was applied and then scrapped off.

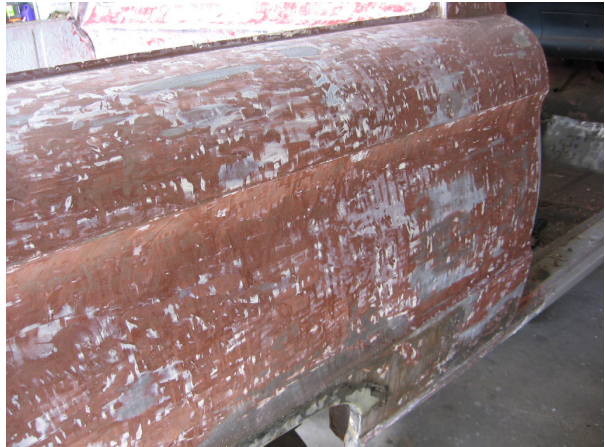
The right rear quarter after multiple coats of stripper and scraping. The original red oxide primer indicates it is almost totally stripped.

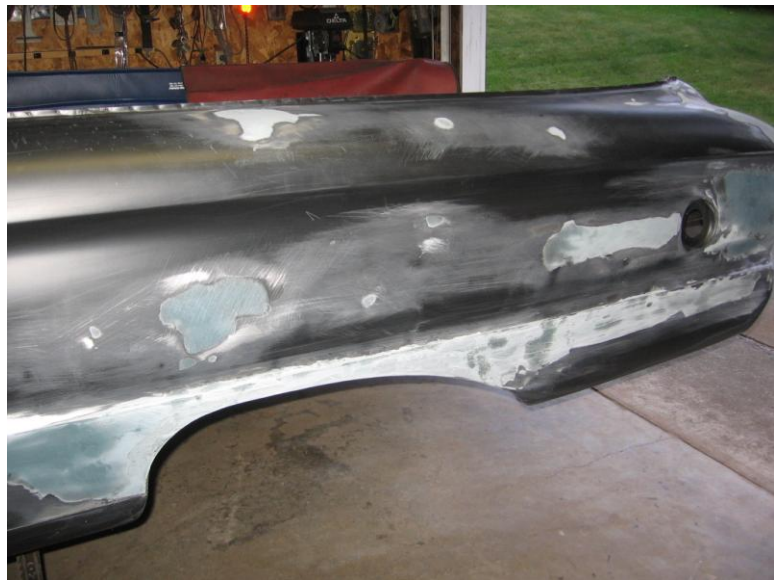
Short kitty hair filler has been applied and sanded.

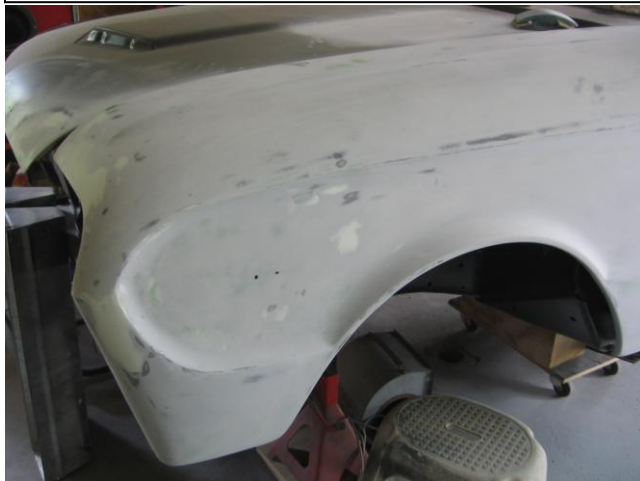
Guide coat sanded off. The dark spots are either the base primer showing through or the guide coat sitting below the level body surface. The lighter shade is filler.

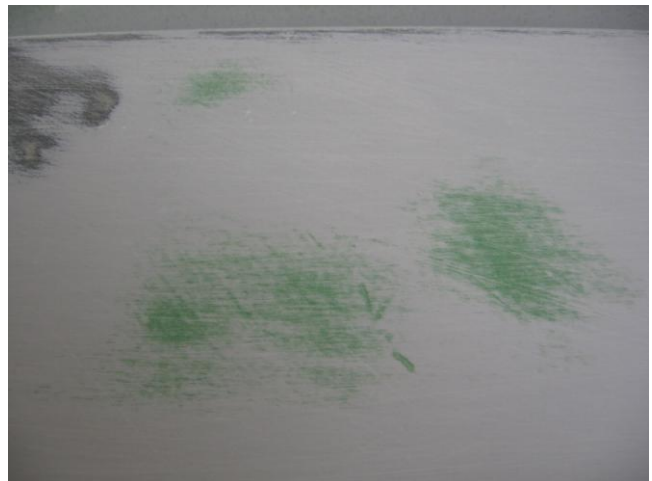
Close up view of a low spot (green) that will require more filler.

Once the sheet metal is close to level, two to three heavy coats of high-build polyester filler (another type of primer) is sprayed on. Before sanding a contrasting color paint is misted over the high-build polyester filler and the surface is block sanded. This is referred to as a guide coat and will be removed in the high and flat areas of the body during the sanding process. The guide coat will not be removed in the low areas. More light weight filler is applied in the low areas and this process is repeated until the body is straight and level.

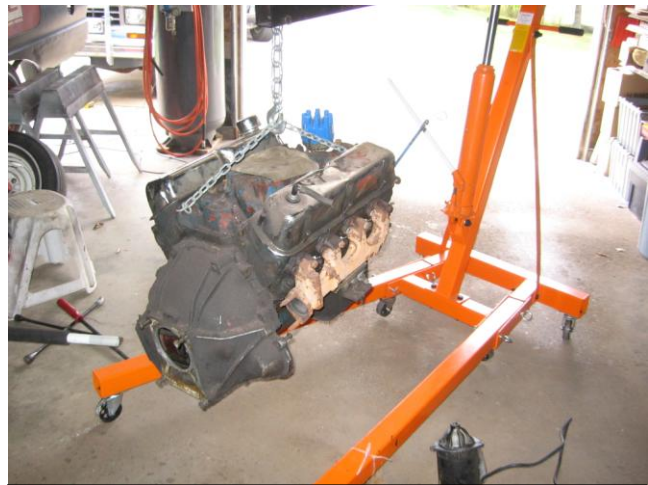
Engine pulled. Under all the grease were three paint jobs, original semi-gloss black, then red and finally Ford blue.

It turns out the engine is a 289. Most all of the parts (block, heads, cam, harmonic balancer, water pump housing, exhaust manifolds) are dated coded correctly for the Ranchero. Rancheros did not come with 289's in 1963, but 289's were used in Fairlanes that were also assembled in San Jose. Was it a replacement engine? Was it an assembly line mistake? I doubt it was a rebuilt engine because of all the correct date codes, particularly the heads (both the same date code). Before doing a complete disassembly, I pulled the oil pan and inspected the rotating assembly. It turns out the engine had a recent rebuild. The crank and rods were all .010" undersized. A quick check of the clearances with plastigage indicated that the clearances were right on specification. The cross hatch honing was still visible in the bores; the cam was stock for the 260 V8 and in very nice condition. So the plan changed and the engine would get re-gasketed, cleaned up and reinstalled. The engine oil leaks were due to no O ring on the distributor, sucked in intake end gaskets and broken oil pan bolts.

The engine got degreased and repainted. Most all the gaskets and seals were replaced. The engine had a cast iron Ford 4-barrel intake (1965 date code) with a Weber 4-barrel (same as AFB or Edelbrock). The carburetor was replaced with a Ford 4100 - 1.08 venturi. Competition Cams steel roller tip rocker arms and push rods were substituted. The engine was returned to its original colors and correct year Ford chrome valve covers were used to dress the engine up some. The generator was replaced with an alternator to save weight and provide more amperage to energize all the additional power robbing accessories that will be added.

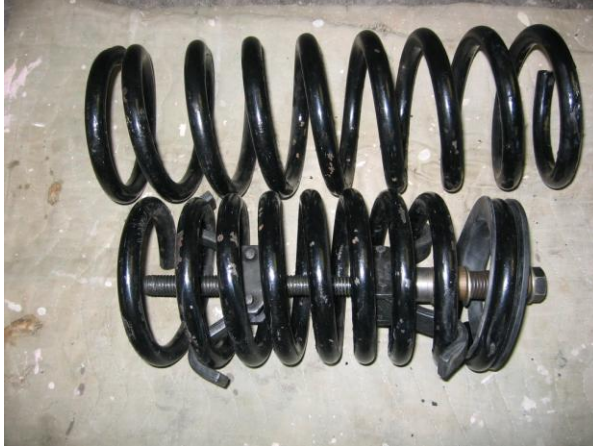
It doesn't look dangerous! Even with the threads greased on the spring compressor, the screw gets hot from the force of compression.

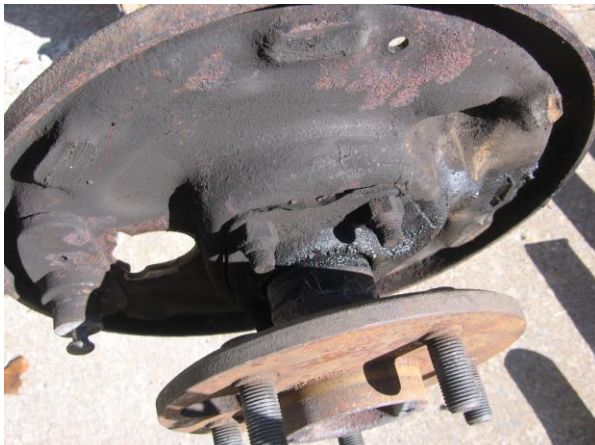
The grease seal is history! Much easier to replace while it is on the cart than on the Ranchero!

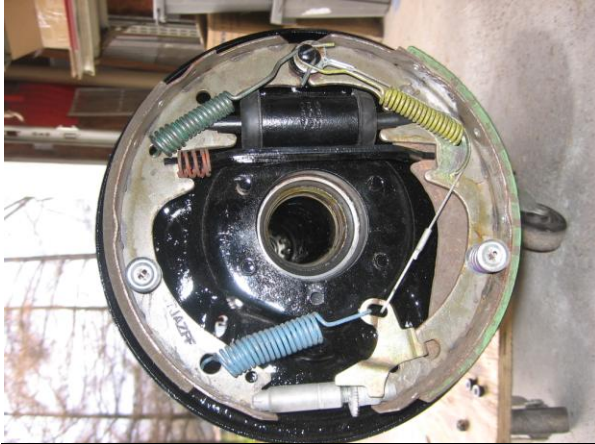
The brake shoes and hardware were in like new condition. Clean it up and put it back together.

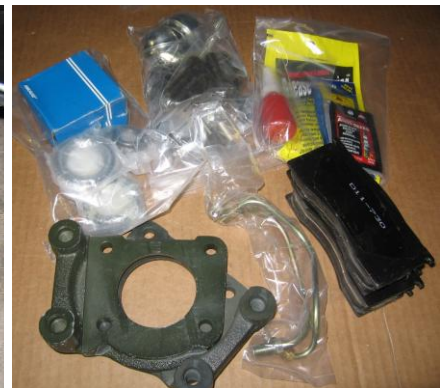
The CSRP brake kit includes everything you need including grease, thread locker and anti-seize.

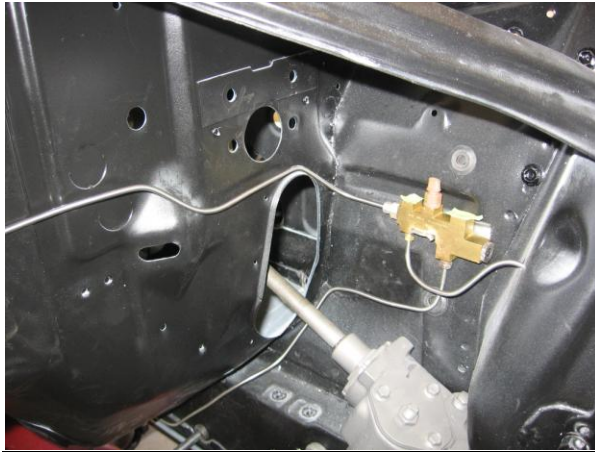
Ford distribution block with the stainless steel brake lines installed.

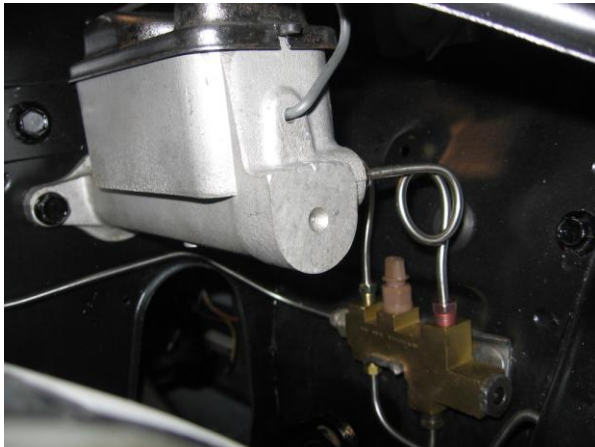
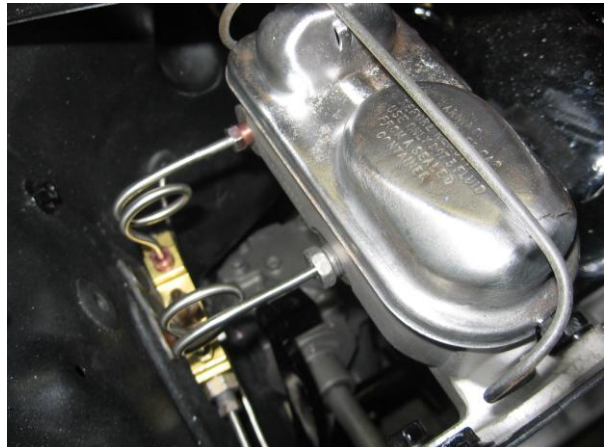
Two views of the master cylinder, notice the loops in the brake lines going from the master cylinder to the distribution block. The loops serve two purposes: 1. they make it easier to tweak the alignment and 2. they allow some flex to minimize stress at the fittings.

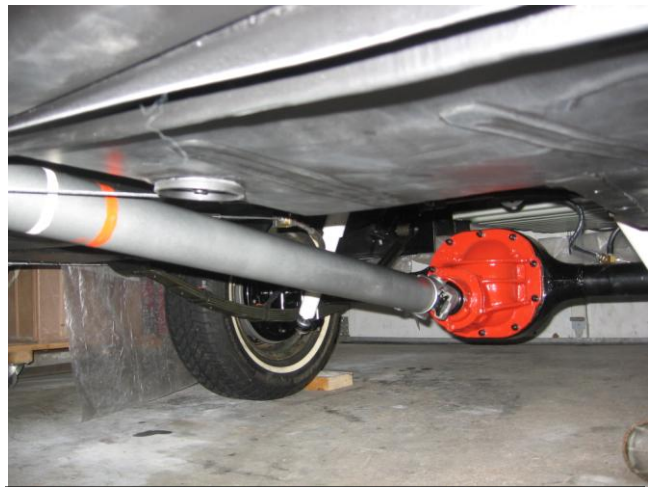
Drive shaft installed, the orange and white stripes duplicate the original factory markings.

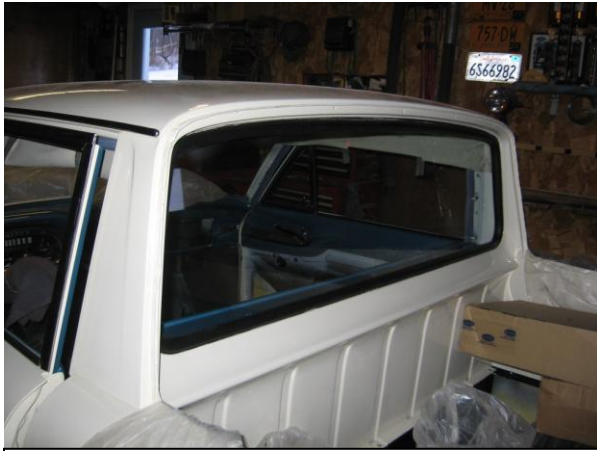
The back window was extremely difficult as its design required installation from the inside.

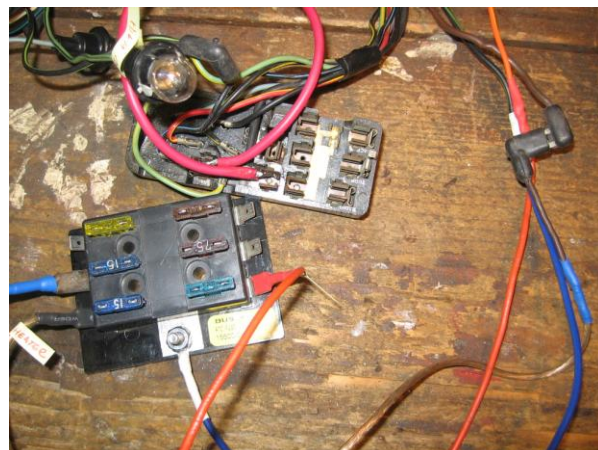
The process of bi-passing the light switch fuse panel to a remote fuse panel.

The entire wiring harness was removed. This was done so it could be modified and repaired. It also is nice to have it out of the way during the painting process. The harness going back to the taillights had been melted together and a three foot section had to be replaced. The engine harness was modified for an alternator with a mini regulator attached to its backside. The headlight harness was converted to a relay system since the original circuit breaker in the headlight switch can not handle amperage required to operate Halogen headlamps. The under dash harness was modified to accommodate emergency flashers, intermittent wipers and the instrument cluster got an additional warning lamp for the high beam indicator so the left and right directional signals each have their own indicator lamp. A Secret Audio system and inflatable lumbar in the seats also required a significant investment of time to tie into the wiring. Lastly, the fuse block on the light switch was replaced with a new fuse block that is mounted above the drivers kick panel. A lot of time and effort was put into these modifications, but they make a big difference in the electrical performance and convenience.

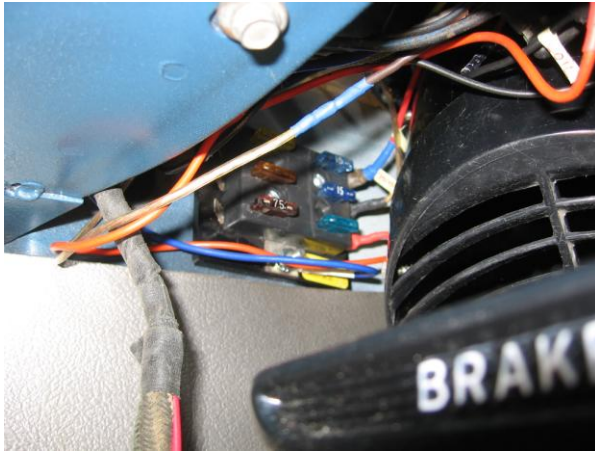
The new fuse block fastened to the left kick panel. You can also see the top of the 64/65 remote control fresh air vent in place of the original 63 air vent.

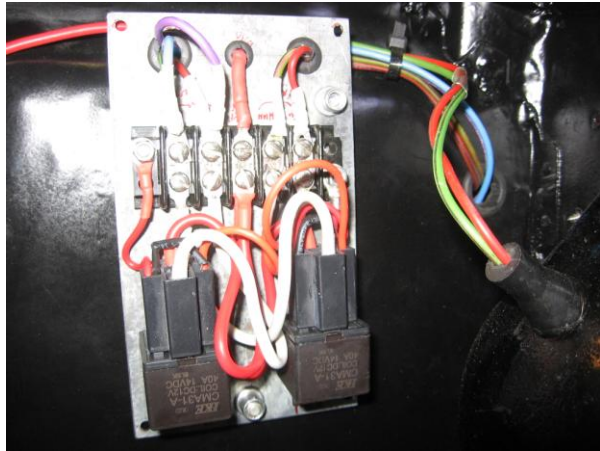
The headlight relay panel is mounted to the back side of the battery box area under the right fender. The cover was removed to show the relays and the wiring.

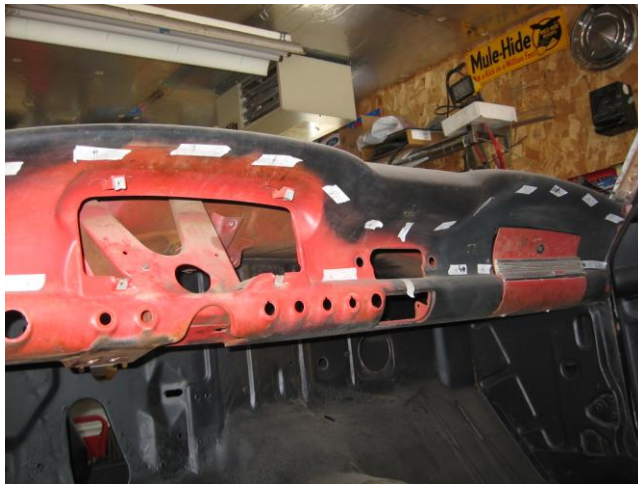
Dash pad and Futura dash trim holes were marked and drilled very early in the restoration process.
